Evaluation Of Carbon Steel, Aluminum Alloy And Stainless Steel Protective Coating Systems After 18 Months Of Seacoast Exposure

May 1984

David Ruggieri
Anne Rowe
Engineering Development Directorate
Ground Support Office
Materials Analysis Office
Materials Testing Branch

MTS-341-82E

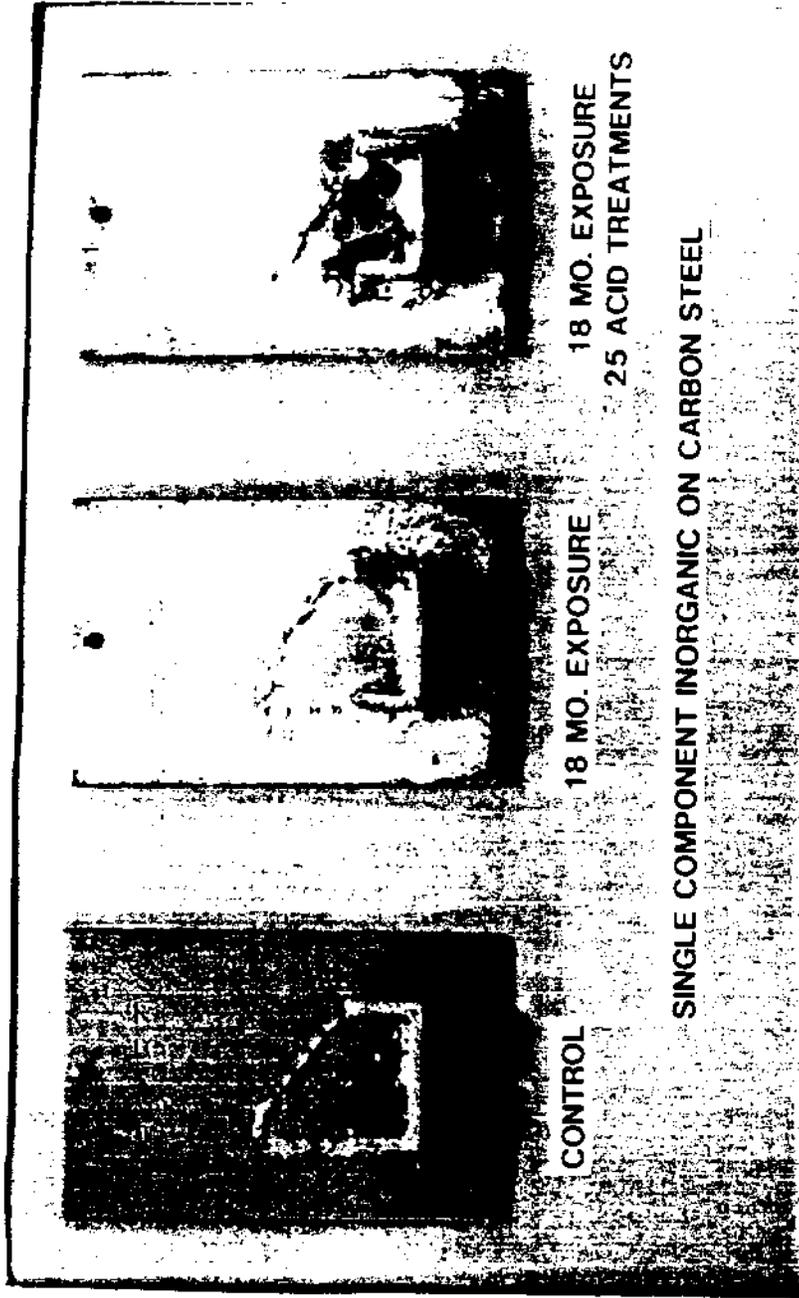
FIGURE 9
UNTOPCOATED SINGLE-COMPONENT INORGANIC ZINC, AFTER 18 MONTHS OF NORMAL AND ACID EXPOSURE

- 4.2.9 At the "18-month" evaluation, many of the coating systems have deteriorated. With the exception of O'Brian Napko 1Z and Subox Galvanox IV, all of the single-component inorganic zincs exposed to normal conditions have failed to meet KSC-STD-C-0001. The two-component inorganic zincs, Ameron D-6 and Mobil 7, exposed to normal conditions are still rated 10. Both the single-component and two-component inorganic zincs exposed to acid effluent have failed. This was expected since zinc dissolves in HCl.

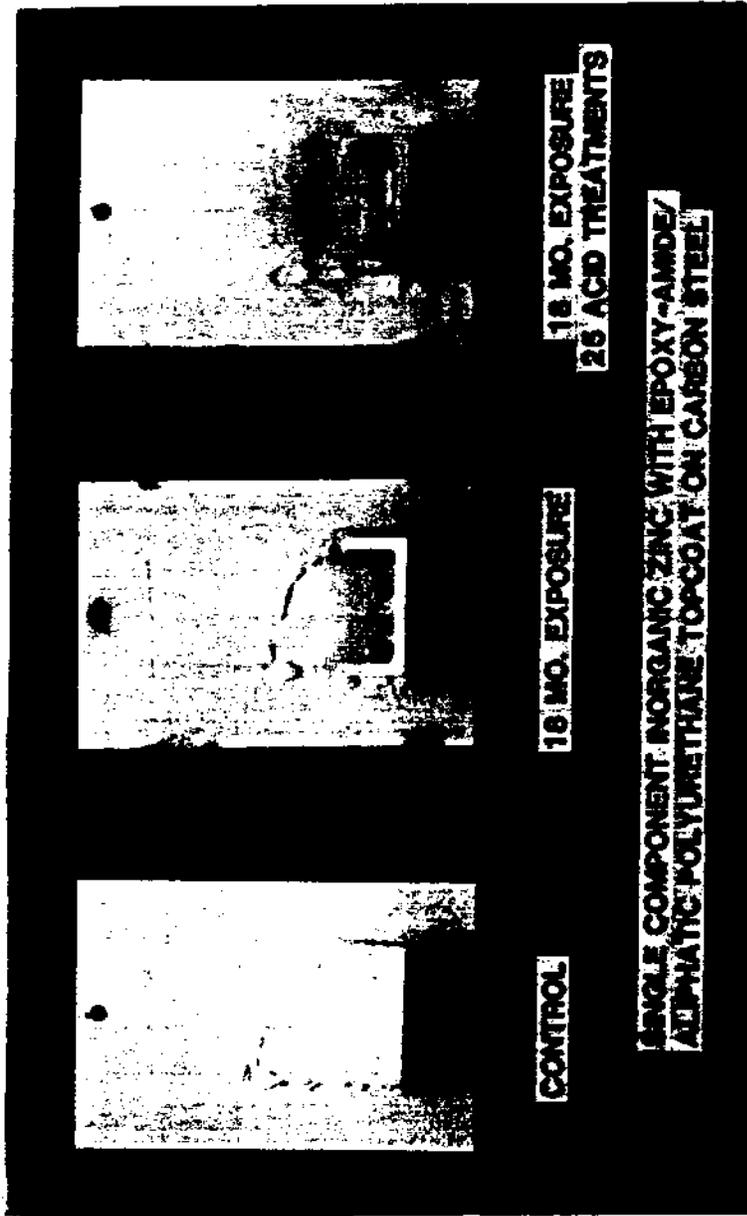
FIGURE 11
TOPCOATED SINGLE COMPONENT INORGANIC ZINC, AFTER 18 MONTHS OF NORMAL AND ACID EXPOSURE

- 4.2.10 The epoxy-polyurethane topcoat systems exposed to normal and acid conditions are not performing as expected. The majority of the epoxy-polyurethane topcoated inorganic zincs exposed to normal conditions are performing worse than the untopcoated inorganic zincs. However, the epoxy-polyurethane topcoated inorganic zincs have been shown to withstand the acid exposure better than the untopcoated inorganic zincs. The alternative topcoat systems have all failed with the exception of Amercoat 741. Amercoat 741 is an inorganic topcoat that has been applied over a single-component inorganic zinc. This coating system is still rated 10 under normal and acid conditions.

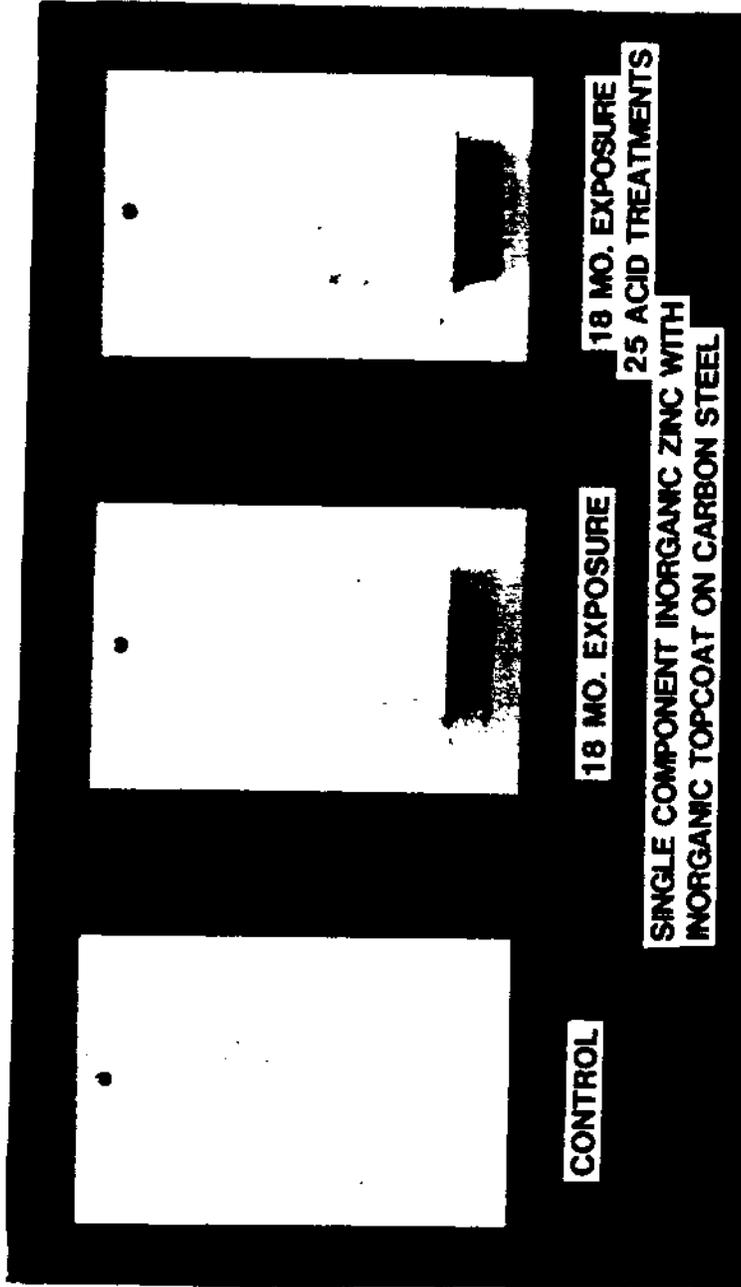
FIGURE 13
INORGANIC TOPCOAT AMERCOAT 741 OVER A SINGLE-COMPONENT INORGANIC ZINC AFTER 18 MONTHS OF
NORMAL AND ACID EXPOSURE

4.2.19 The Carboline epoxy-polyurethane and Amercoat 741 are the only two topcoat systems whose scribed panels are performing with a rating of 5. The majority of the other topcoat scribed panels are showing some spread of rust.

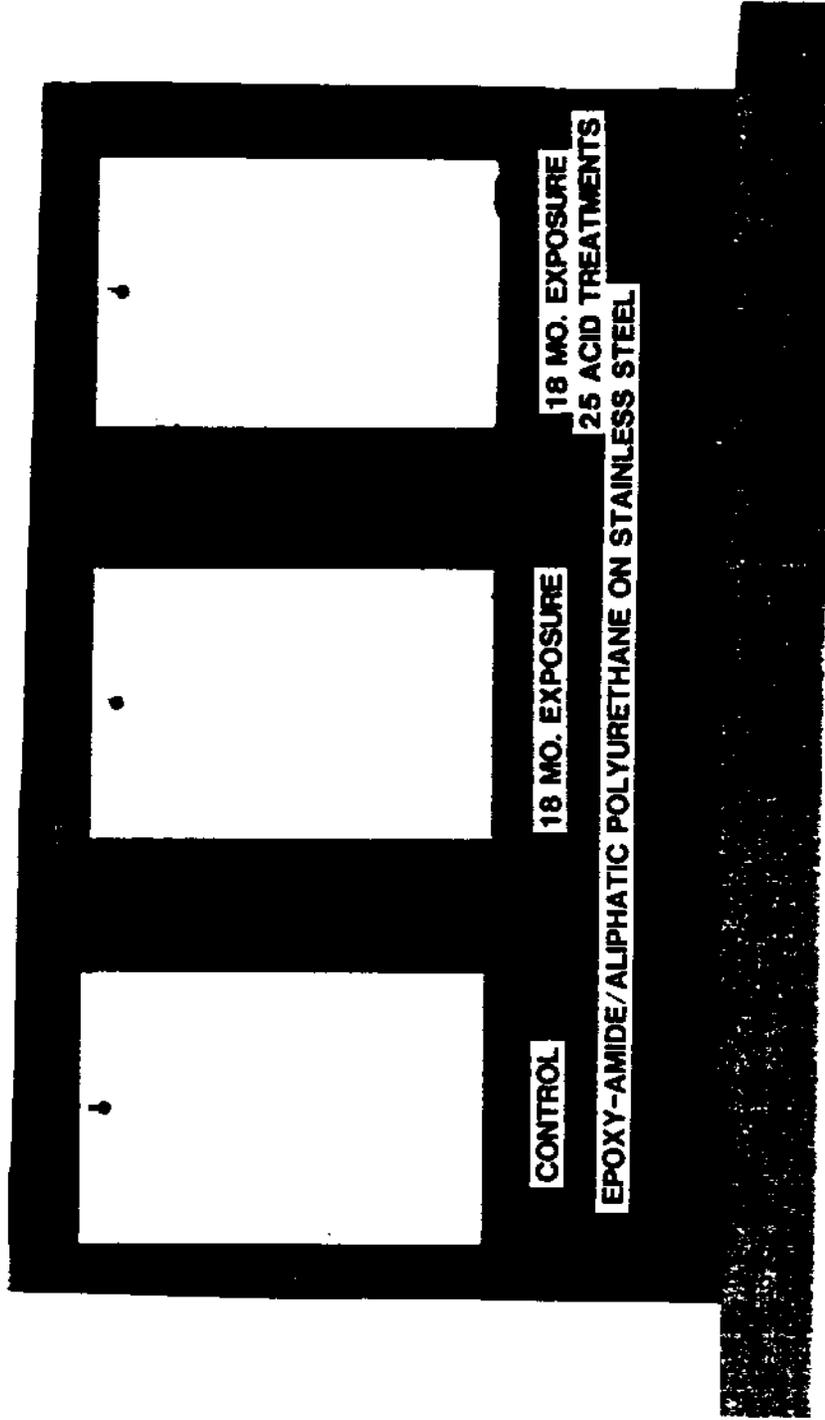
FIGURE 21
EPOXY/POLYURETHANE ON STAINLESS STEEL, AFTER 18 MONTHS OF NORMAL AND ACID EXPOSURE

- 4.2.13 The stainless steel coatings are doing well. It should be noted that the epoxy-polyurethane coating on stainless steel is peeling off the bottom of the panel, but no corrosion has been observed.

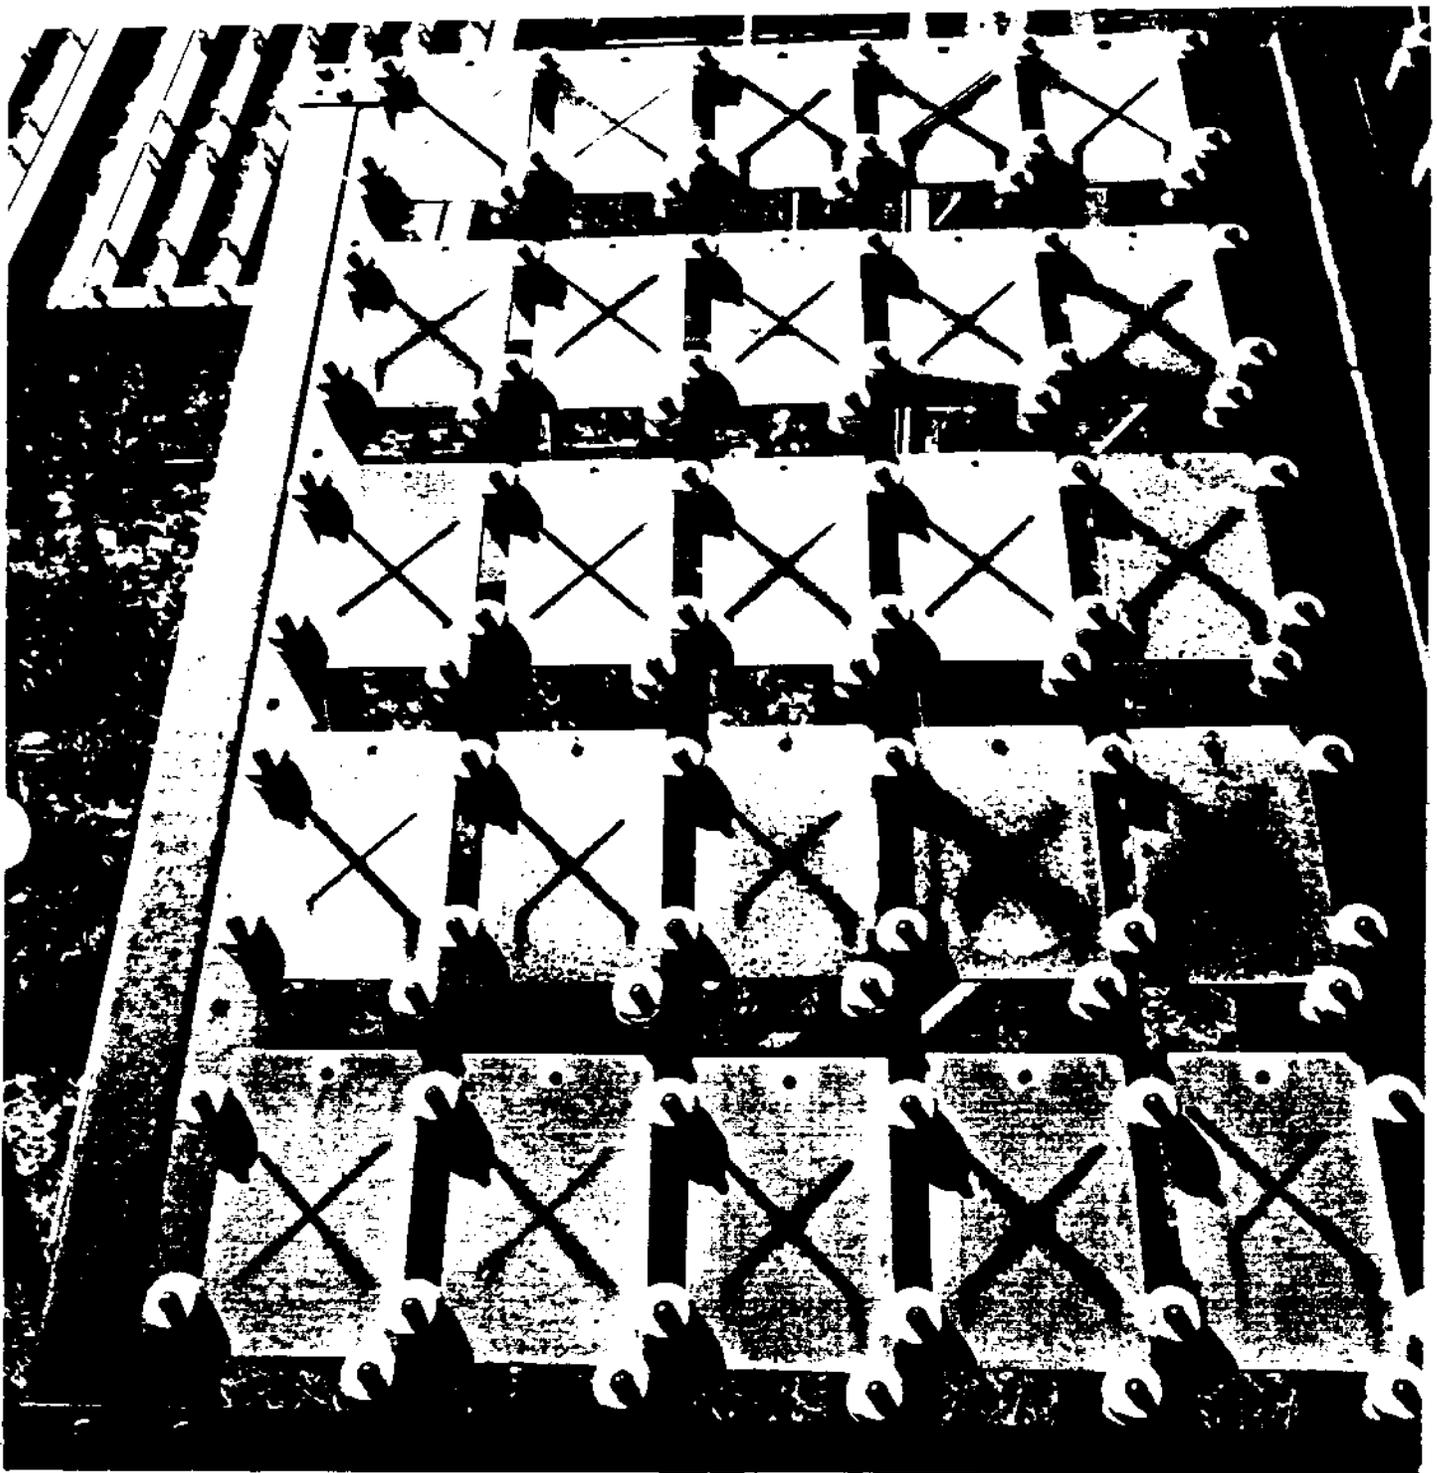
FIGURE 23
SCRIBED PANELS IN VARIOUS STAGES OF CORROSION SPREAD

4.2.20 The coatings on scribed aluminum alloy panels are all showing signs of spreading corrosion. The epoxy-polyurethane and epoxy coatings are exhibiting the worst spread. On the other hand the stainless steel scribed panels are showing no signs of spread.

4.2.21 The results of the scribe tests are shown in Table IV. Figure 23 shows a rack of scribed panels in various stages of corrosion spread.
