NASA
DIRECTOR OF ENGINEERING DEVELOPMENT
DIRECTOR, MECHANICAL ENGINEERING
MATERIALS SCIENCE LABORATORY
FAILURE ANALYSIS AND MATERIALS EVALUATION BRANCH
MATERIALS SECTION
DM-MSL-22, ROOM 2221, O&C BUILDING
KENNEDY SPACE CENTER, FLORIDA 32899

92-2150

SUBJECT: SPRAYABLE SILICONE ABLATIVE COATING, GE PRODUCT CODE
CPC-1050, POST LAUNCH EVALUATION ON LAUNCH COMPLEX
40, CAPE CANAVERAL AIR FORCE STATION

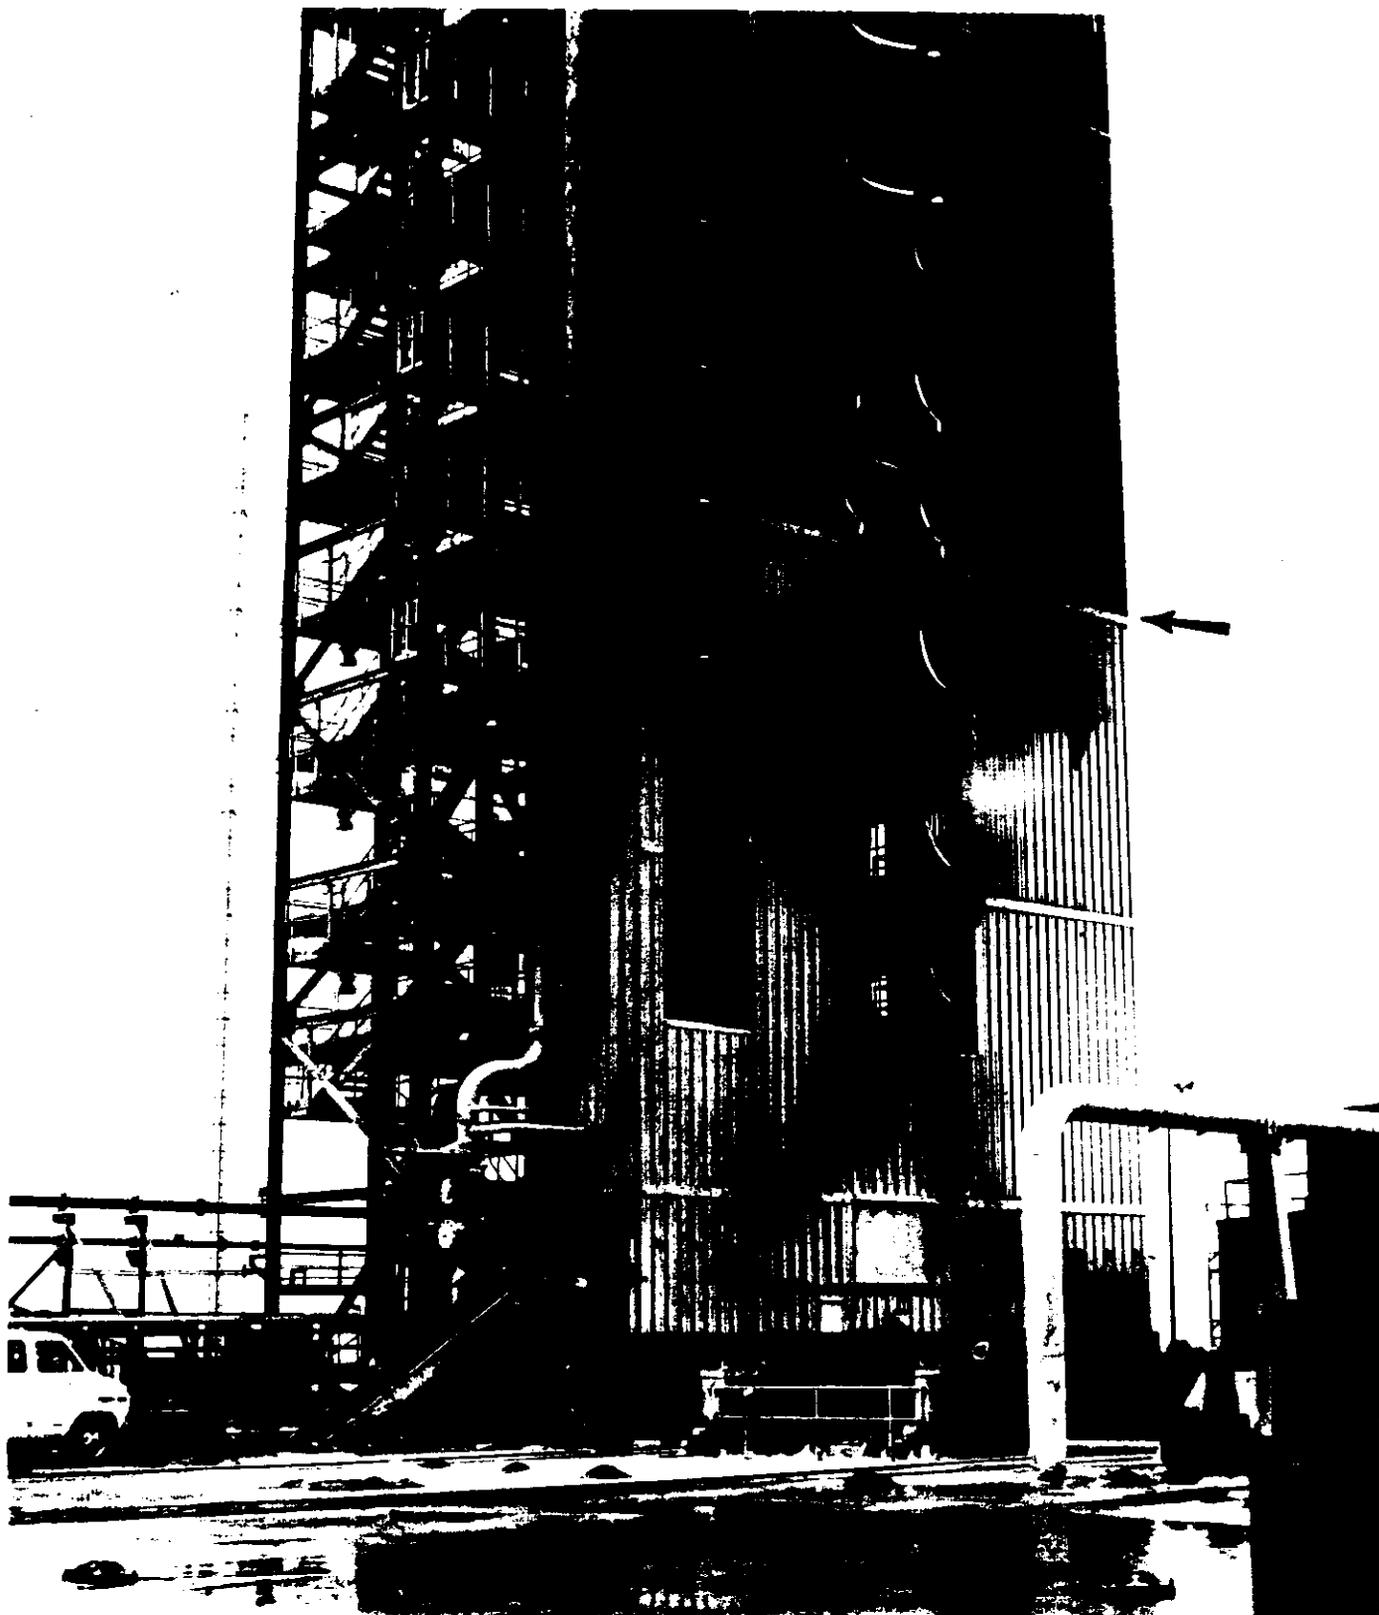
FIGURE 1

5.2 The ablative material applied to the structural steel on the CX-40 UT withstood the thermal and pressure shock loadings associated with the launch, exhibiting little or no loss of thickness due to ablation. Figure 1 shows an overall view of the UT. The arrow indicates the transition from the silicone ablative coating and the steel coated with 4-6 mils of inorganic zinc only. Approximately 30% of the surface of the silicone ablative on the east

face was covered with a black, sooty material easily removed with finger pressure. The sooty material is probably the combustion product from organic material used in the launch pad area. Low pressure water washing can be used to remove this material.

OVERALL VIEW OF LAUNCH COMPLEX 40 UMEILICAL TOWER. THE ARROW INDICATES THE TRANSITION FROM THE SILICONE ABLATIVE COATING (GRAY) TO INORGANIC ZINC PRIMER (GREENISH-GRAY).

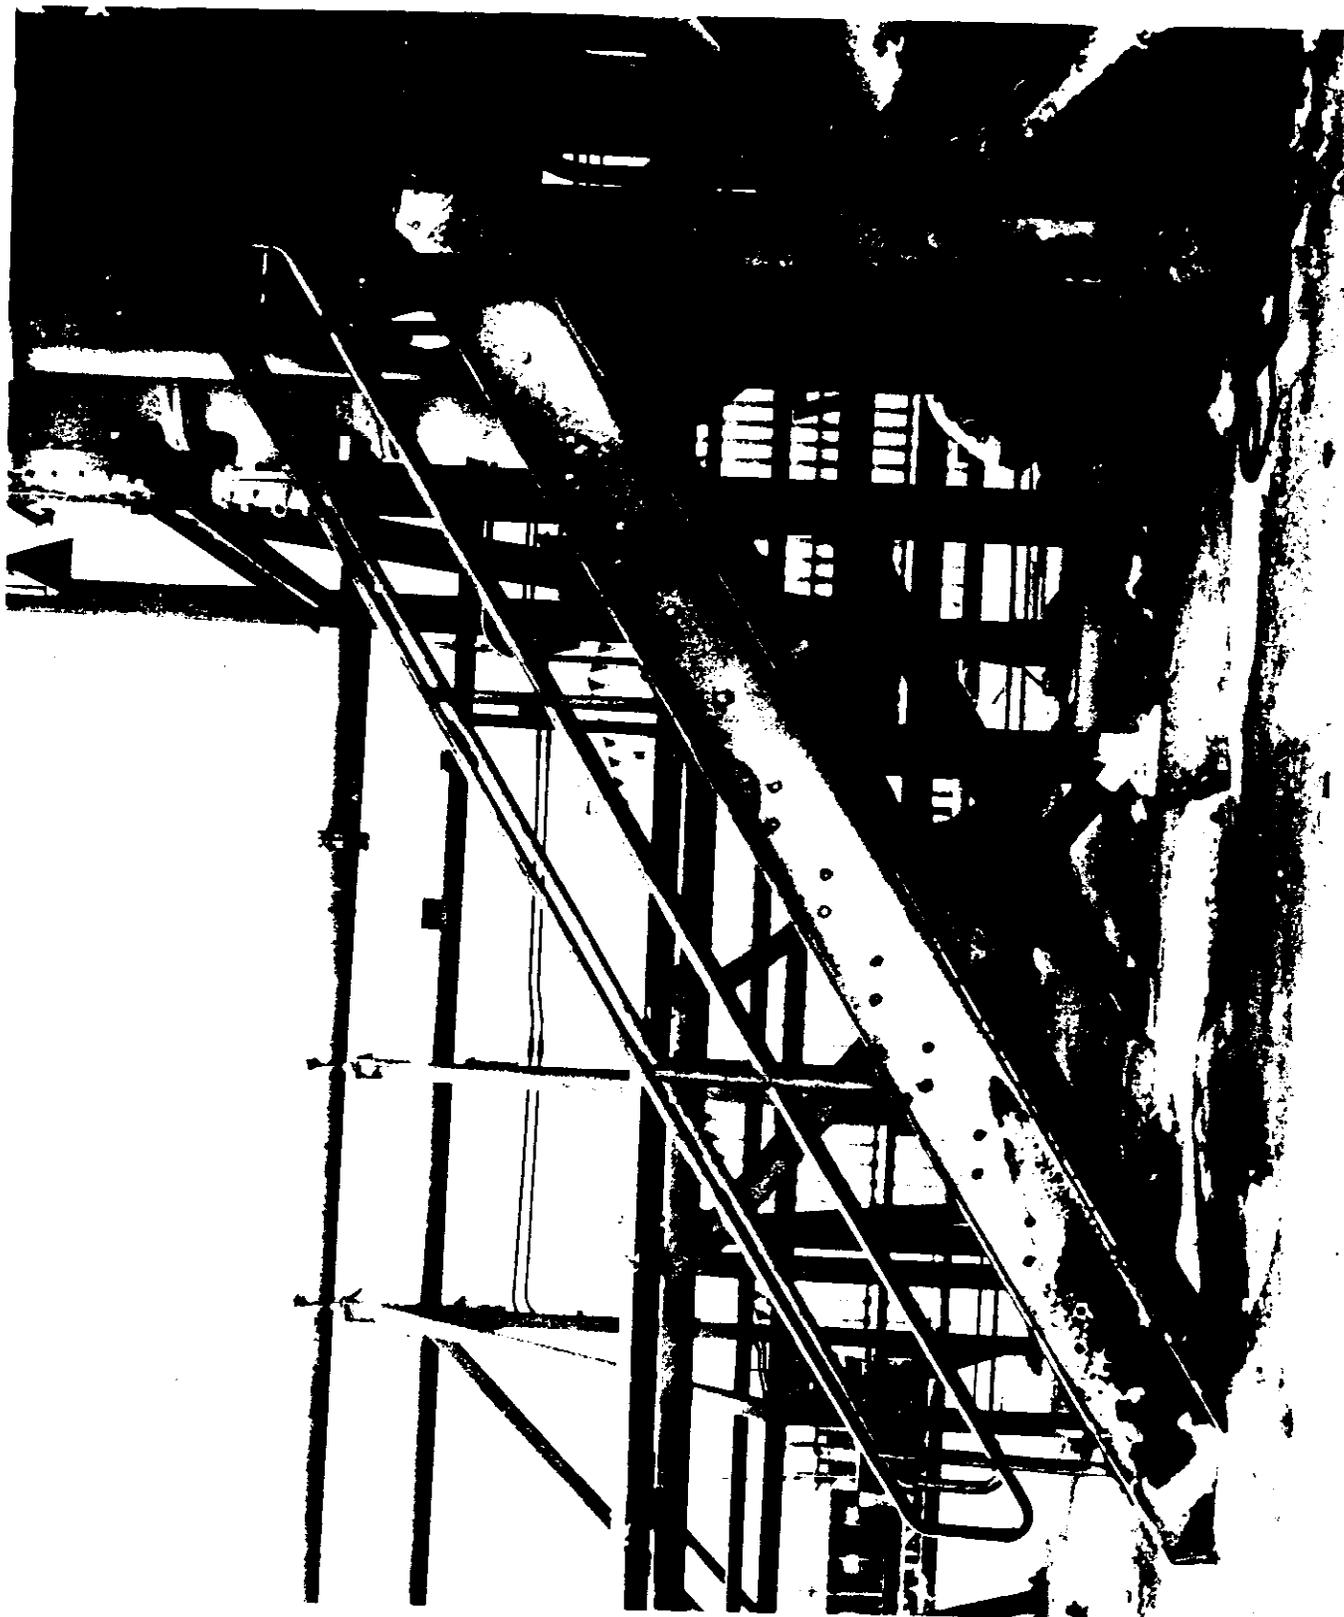
FIGURE 13

LAUNCH DAMAGE TO UNPROTECTED STAIRWAY ON SOUTHEAST CORNER OF UMBILICAL TOWER. THIS AREA SHOULD BE COATED WITH ABLATIVE.

- 7.3 Future applicators should be trained to achieve a more uniform film thickness. Wide variation in applied thicknesses in the present case was probably caused by the lack of familiarity with the coating and the plural component spray rig required for application. Lack of control of film thickness will affect the materials cost, as well as jeopardize the underlying steel structure.
- 7.4 Several areas, not coated with silicone ablative, should be coated in the future. Items include: Electrical panel blast shields (Figure 10); EAGE building doors (Figure 11); Piping supports of the south end of UT (Figure 12); Ladder at the southeast corner of UT (Figure 13); Launcher supports (figure 14); Deflector supports (Figure 15); and miscellaneous ground hardware (Figures 16 and 17).
