CORROSION OF STAINLESS-STEEL TUBING IN A SPACECRAFT LAUNCH ENVIRONMENT

ABSTRACT

This is a report of exposure of various metal tubing to oceanfront launch environment. The objective is to examine various types of corrosion-resistant tubing for Space Shuttle launch sites. The metals were stainless steels (austenitic, low-carbon, Mo-alloy, superaustenitic, duplex, and superferritic), Ni-Cr-Mo alloy, Ni-Mo-Cr-Fe-W alloy, and austenitic Ni-base superalloy.

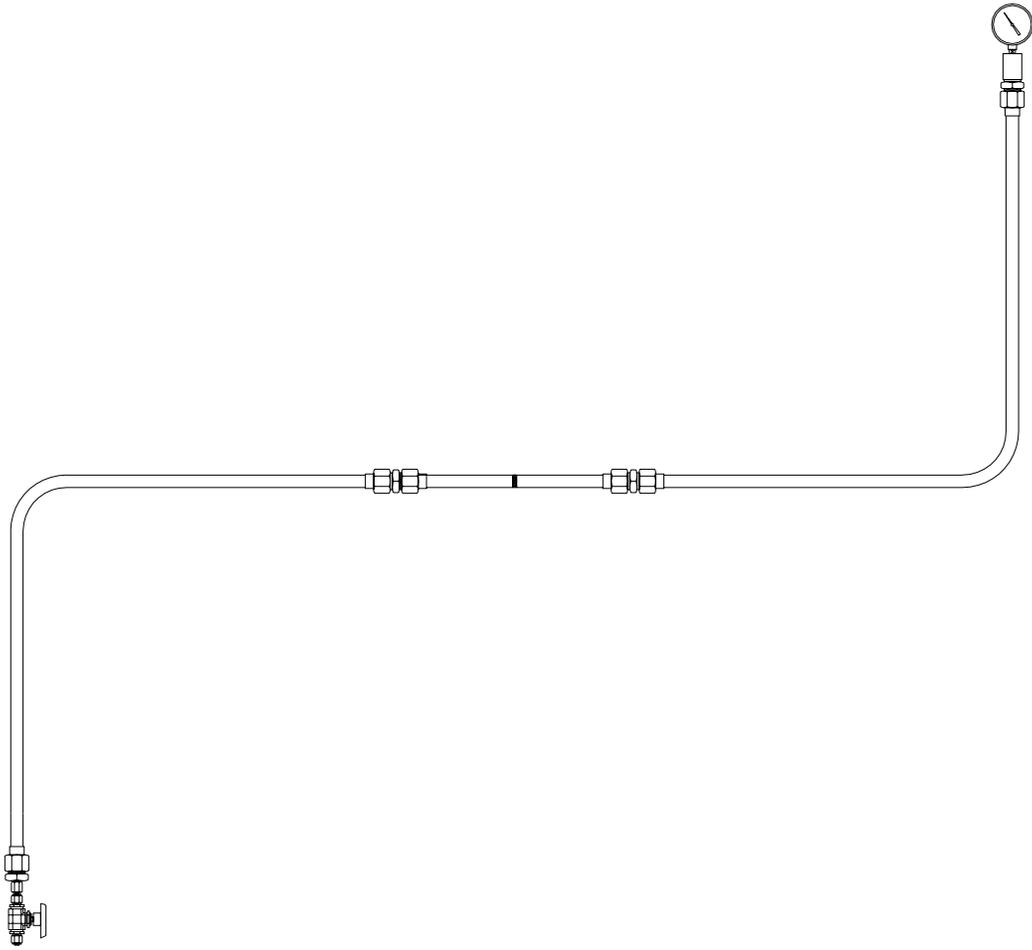
Figure 1 – Fabrication of tubing test articles

Each tubing test article was prepared from three sections, an upper section, lower section, and a center section (Figure 1). The upper and lower sections each have a 90° bend, bent per KSC-SPEC-Z-0008C (Specification for Fabrication and Installation of Flared Tube). The center section is a 12-inch length of straight tube that has been cut and orbital-fuse welded back together. Welding was performed on an automated orbital welder per NASA-SPEC 5004 (Welding of Aerospace Ground Support Equipment and Related Non-Conventional Facilities). Only visual inspections of the welds were performed. The ends of each piece were flared adhering only to diameter dimensions listed in SPEC GP425F – KC154 (Fluid Fitting Engineering Standards). Table 3 lists the KSC-SPEC-Z-0007E (Specification for Tubing, Steel, Corrosion Resistant, Types 304 and 316, Seamless, Annealed) wall thickness variations and discontinuities for each alloy versus the ASTM standards.

Each piece of tubing was pressure proof tested per KSC-SPEC-Z-0008C and blown dry with GN₂ before being assembled. 304-stainless-steel KC fittings were then used to assemble the three sections of tubing together in an S-shaped configuration as shown in Figure 1. A pressure gauge was attached to the top end of the tubing, and a ball valve was attached to the lower end for tube pressurization/isolation. Once assembled, the tubing test articles were placed on fabricated stands, pressurized to approximately 2000 psi and checked as an assembly for leaks. The stands were then transported to the KSC Beach Corrosion Test Site during the week of March 6-9, 2000 for test and evaluation.

Figure 1 - Fabrication of tubing test articles

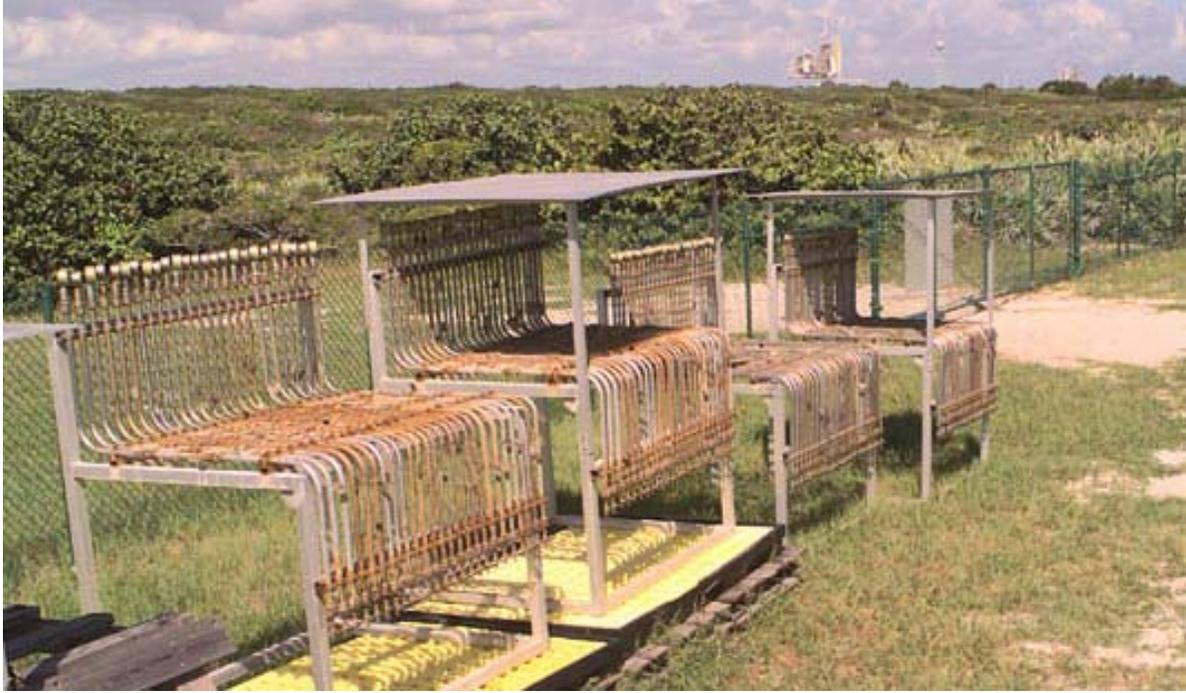
Figure 2 – Racks at the Beach Corrosion Facility

A total of 98 tubes were mounted on four stands. Two of the four stands were built with a protective roof (cover). The covers were put in place to reduce the sun and rain exposure of the test articles. Table 4 lists the tubing material, tubing OD, placement on the rack, rack covered (yes or no), acid wash (yes or no), and the number of tubes per rack. A table of workability problems that were encountered during fabrication of the tubing test articles can be found in the Appendix.

It should be noted that one tubing test article was fabricated from Material 254 SMO that was furnace annealed rather than line annealed. This tubing test article has been hung on rack # 2 (covered and acid rinsed). The workability for this sample was found to be superior to line-annealed tubing and was said to be comparable to the workability of the standard 304 stainless-steel used presently on center. Figure 2 shows an overview of the four racks located at the beach corrosion facility.

Figure 2 - Racks at the beach corrosion facility

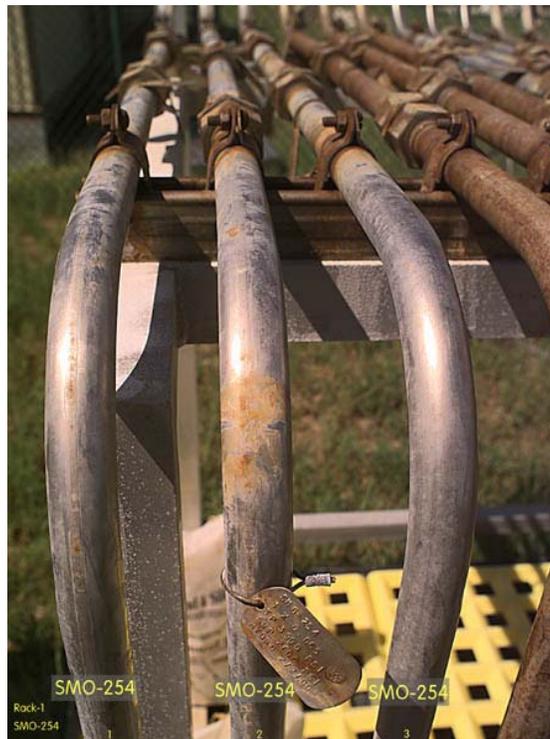
Figure 3 – SMO-254

Preliminary evaluation of the tubing test articles shows that all of the nickel-based alloys (primary constituent nickel), C-2000, Alloy 276, and 625 along with iron-based alloys 254 SMO and 2507, shows little signs of corrosion. The 304L, 316L, and 317L alloys show the greatest signs of corrosion. AL-6XN shows distributed corrosion over the entire surface of the tube. Earlier testing showed that this same material had better corrosion resistance under similar test conditions. It has been suggested that the tubing surface was not properly conditioned, causing the difference in performance. The remaining alloys, AL29-4C and 2205, show moderate oxidation. Table 5 ranks the alloys in five broad categories, good, fair, fair-poor, poor, and failed. Individual alloys within one bracket, e.g., *good*, were not sufficiently different to rank alloys in a given bracket. Both acid-washed racks show much more corrosion than the racks that have only been exposed to atmospheric conditions. Figures 3 through 11 show the different alloys mounted on Rack 1 in the order that they are placed on the rack from left to right. (Note that triplicate samples of some materials, and duplicate samples of other materials were exposed to see the effect of test replicates. See Table 4 for tubing sequence.) Rack 1 has been acid washed and is not covered. This rack seems to show the highest signs of corrosion to date. Both acid-washed racks show much more corrosion than the racks that have only been exposed to atmospheric conditions.

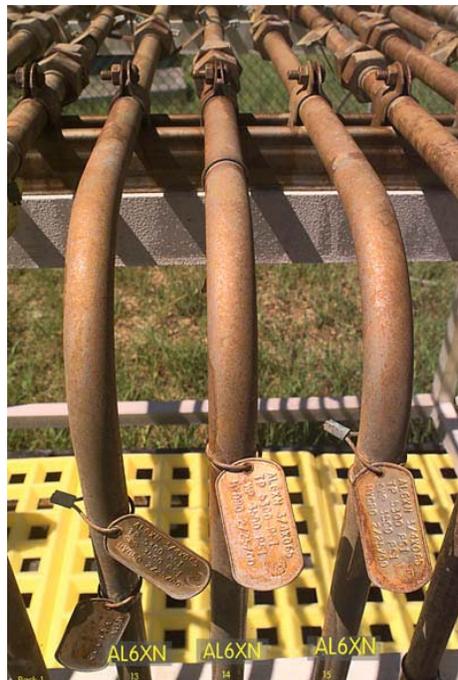
Figure 7 – AL-6XN

Besides the apparent high nickel content in the three nickel-based alloys, the top five performers have higher levels of molybdenum (6.1 to 16.0 percent) with the exception of 2507, which only has 4 percent. The AL6-XN with a molybdenum level of 6.0 to 7.0 percent showed a much higher level of corrosion than the top five. All the 300-series stainless steels with molybdenum levels of less than 4 percent (304L with 0 percent) showed the highest level of corrosion.
